# Shoreline Situation Report

## PRINCE WILLIAM COUNTY, VIRGINIA

Special Report In Applied Marine Science and Ocean Engineering Number 119 of the

VIRGINIA INSTITUTE OF MARINE SCIENCE

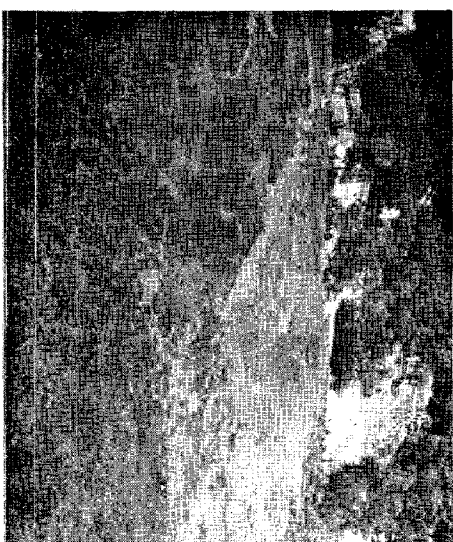
FIGURE 6

FIGURE 6: Embayed marsh fronting new development on Quantico Creek (Segment 4). Residential buildings behind valuable marsh areas are environmentally sound if proper precautions are taken to ensure there are no harmful effects on the marsh system.

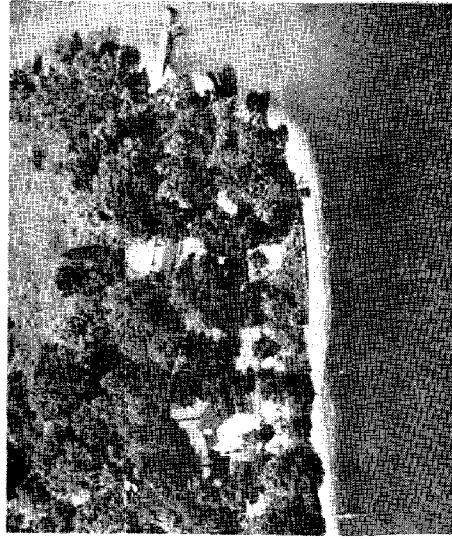
FIGURE 9

FIGURE 9: North end of Chopawamsic Island (Subsegment 5A). The house in the foreground is endangered by continued erosion of the bluff. Two sets of bulkhead seem to be ineffective in combatting the erosion problem. Downhill rain runoff is also a major factor in the erosion of the cliff.

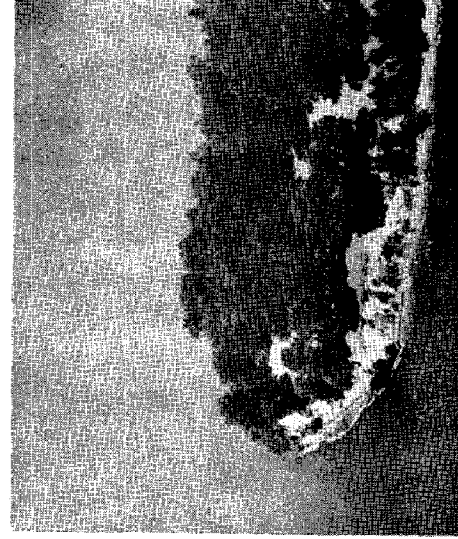
FIGURE 10

Several factors influence the location and rate of erosion for any section of shoreline. Along a major river such as the Potomac, a primary cause of erosion is wind generated waves. In bluff areas, waves attack the exposed cliff base. This process eventually undercuts the base of the cliff, causing the upper portion to slump. The height and growth of waves is controlled by four factors: The overwater distance across which the wind blows (the fetch), the velocity of the wind, the duration of time that the wind blows, and the depth of the water. Prince William County is affected by storms out of the northeast and southeast. Fetches during northeasters range from 2.5 to 6.6 nautical miles and during southeasters from 3.5 to 10.0 nautical miles. The southern end of Chopawamsic Island, having a fetch of 10.0 nautical miles from the southeast, has moderate erosion. Only pilings remain from an earlier attempt at bulkheading this section (see Figure 10).

FIGURE 10: South end of Chopawamsic Island (Subsegment 5A). The bulkheading of this area has failed, leaving the cliffs exposed to wind generated waves from the southeast.
